Clinical Sheet

GUIDED BONE REGENERATION IN ESTHETIC DENTISTRY

Use of bone granules of equine origin
and of a collagen membrane.

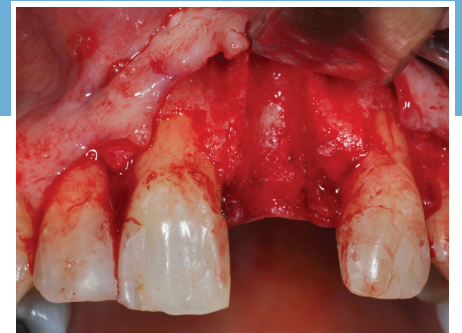
Fig. 3 - Extraction of the compromised tooth. Please note the presence of the vestibular defect.

Given the presence of a horizontal defect of the alveolar ridge at the site of tooth 2.1, the patient was treated with the guided bone regeneration technique and, at the same time, with the insertion of a dental implant to replace the compromised tooth.

Having opened a full thickness flap without releasing incisions from the mesial 1.2 to the mesial 2.3, the surgeon extracted tooth 2.1 non-traumatically. He inserted the implant at the position 2.1, slightly palatalized, and he inserted the previously shaped collagen membrane along the palatal side. He filled the vestibular defect with

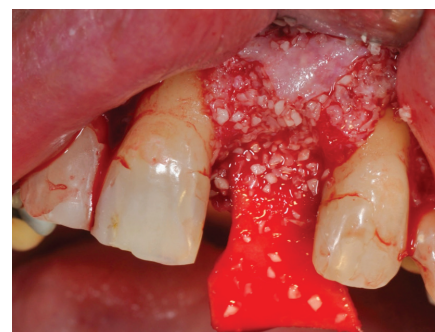
Fig. 5 - The collagen membrane is shaped and inserted palatally. A graft of heterologous granules is placed in the vestibular defect.

The case described entails using an equine bone substitute (Bioteck) consisting of a 1:1 mixture of cancellous and cortical granules sized 0.5-1 mm, in conjunction with a collagen membrane (Biocollagen, Bioteck).

bone substitute granules of equine origin. He then flexed the membrane to cover the site of the graft and inserted it in the vestibular side. He ended by bringing the flaps together and suturing them.

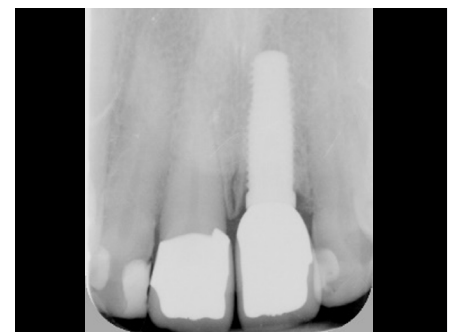
Fig. 12 – X-ray 12 months after the procedure.

X-ray imaging 12 months from the implant insertion showed that peri-implant levels had been preserved and there was no sign of bone resorption.
